SB 09

SERVICE BULLETIN No. 09

Brake pad wear and condition for replacement

Applies to all Sinus/Virus aircraft.

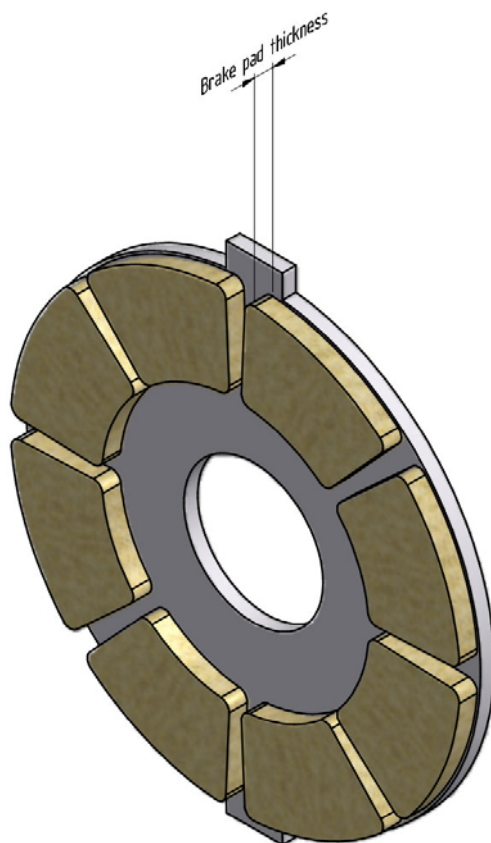
Check the thickness of the brake pads in both main wheels of the undercarriage. Brake pad thickness is critical for adequate braking action and integrity of the system.

WARNING! Worn-out brake-pads will degrade braking action and/or cause the wheel brakes to fail completely.

The minimum recommended brake pad thickness for normal brake operation is 2 mm. The absolute minimum brake pad thickness is 1.5 mm. Should the actual brake pad thickness be less, replace the brake-pad with a new part immediately.
