SERVICE BULLETIN No. 10

Replacement of oil pressure sender

Applies to Sinus/Virus/Virus SW aircraft.

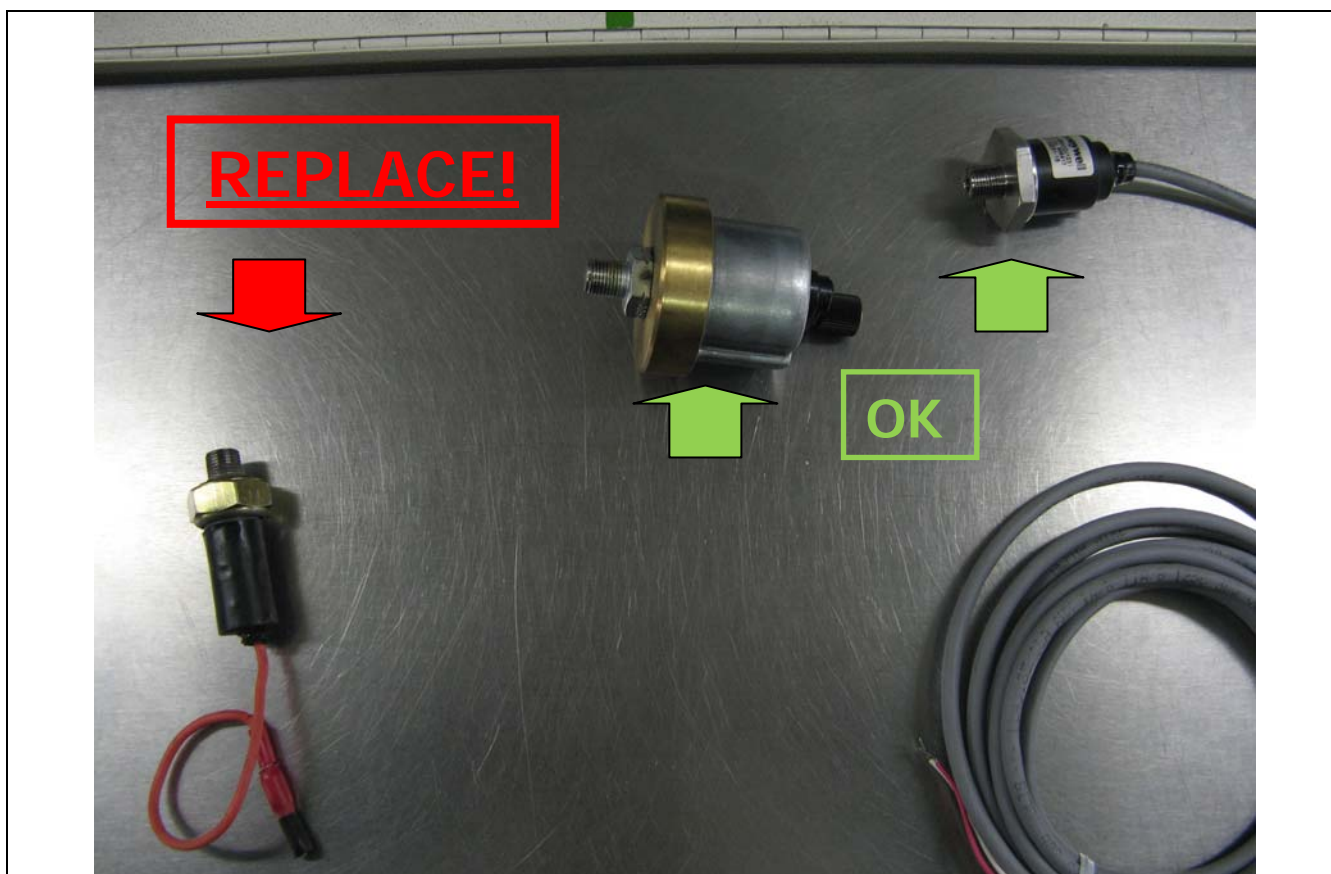
There was a reported case of oil leaking through the oil pressure sender on a Virus 912. Upon closer investigation it became apparent that the specific oil pressure sender (digital – switch type) is not reliable over its serviceable life and has a potential to develop an oil leak through the sender head, causing the oil to escape and effectively producing loss of oil pressure in the engine. Due to the potential hazard of engine failure in any stage of flight, we have decided to order replacement of all oil pressure senders of the type in question with immediate effect. Replace the problematic oil pressure sender with the following new sensor:

The required time for replacement of the oil pressure sender is 1 hour. You will only need basic tools and a plastic cable tie. First, identify whether your aircraft has the problematic oil pressure sender. It is possible that it was already replaced for another type during servicing. Use the following photograph for identification:

Rotax Pressure Sensor Assy. PN 956357 (15 Nm / 135 in.lb. torque)

Having identified the oil pressure sender, expose the wire and disconnect the sender wire. Unscrew the oil pressure sender and replace it with the new unit. Reconnect the wire and make sure that the wire

connection (joint) is sealed against contaminants. Cut the existing cable tie, pull out the connector and replace it with a new, good one. Make sure you apply a new cable tie and test for the seal. Before doing this, make sure you have disconnected the battery from the circuit.
