## ELA AVIACIÓN, S.L.

### Service Bulletin/Boletín de Servicio No. 10E-271025 (Rev 2)

#### Fuel leak in the pipes

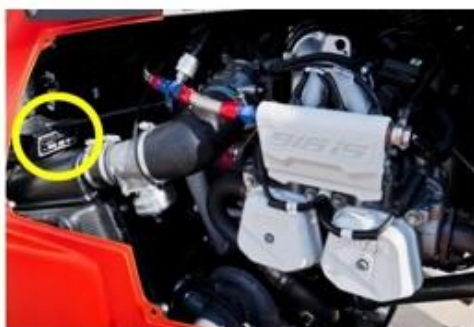
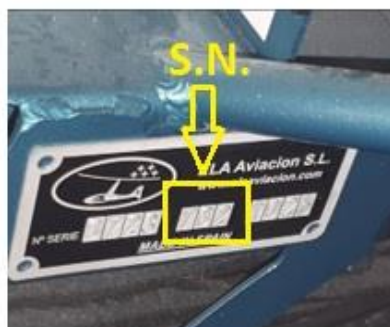
**From 651 to 711 inclusive / Desde el 651 al 711 ambos incluidos**

Operators are requested to verify their aircraft's serial number as indicated in the attached reference image to determine whether the aircraft is within the affected range.
